CAUSED AND DIRECTION OF SOIL MOVEMENT GOMBEL LAMA – PAWIYATAN LUHUR STREET SEMARANG CENTRAL JAVA

ABSTRACT: Soil movements that often occur in many sloping areas cause damage to the infrastructure around the location. Likewise, the soil movement that occurred in the area of Semarang Pawiyatan Luhur street has caused continuous damage to the main street and building facilities as campuses and houses. Joint research conducted by several Universities in Semarang showed that the main cause of soil movement occurred in the region was caused by infiltration in the top area and erosion at south-west of kaligarang riverbanks. The direction of movement based on the results of the research shows that it leads to the Kaligarang river in Semarang. This is evidenced by the results of mapping the crack direction and the geological search that has been carried out. Some of the geo-electric test results as well as deep drill tests accompanied by SPT data show the depth of soil shift shows up to a depth of 60.00 meters from the existing land surface. Some proposed short-term and long-term countermeasures need to be done to minimize the soil movements that occur are regulation of sewerage, soil impr

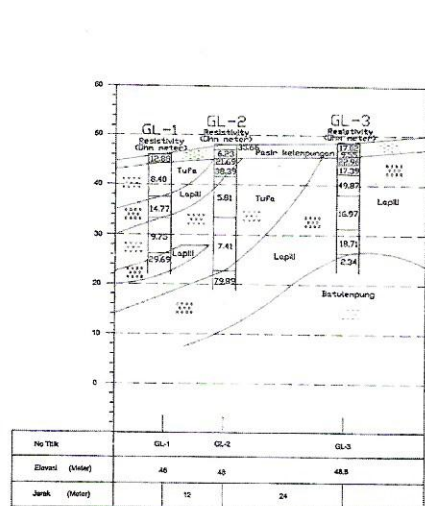
Figure 3a. Section A - A Geoelectric Test Results (Report 2011)

Based on the results of the geoelectric test section A - A and B - B can be seen the type of soil layer that is below the surface of the soil. One of the most important types of soil is known as the presence of clay stones in the geoelectric test results. Clay stones are very important because if there is a flow of water in this layer, it will cause the soil to slip.

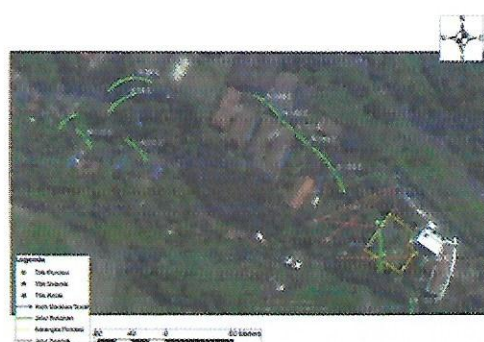
Figure 4a. Fracture of Bendan Dhuwur From Citra Google Earth Unika (UGM Report 2012)

Based on the results of previous research conducted by a team from Gajahmada University (UGM, 2012), it is known that the direction of movement can be described as follows (Figure 4a and Figure 4b) from the fractures. It can be seen that the direction of the soil movement is southwest.

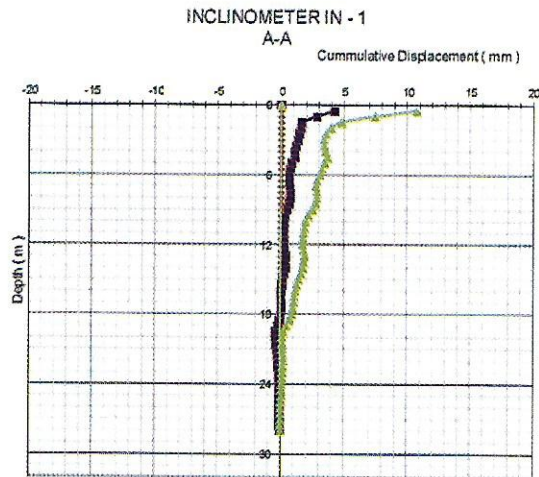
Figure 5a. Inclinometer reading results (source: GEC report, 2014)

Monitoring from inclinometer's instrumentation showed the depth of landslide at 18.00 – 20.00 m from the ground surface (Figure 5a).

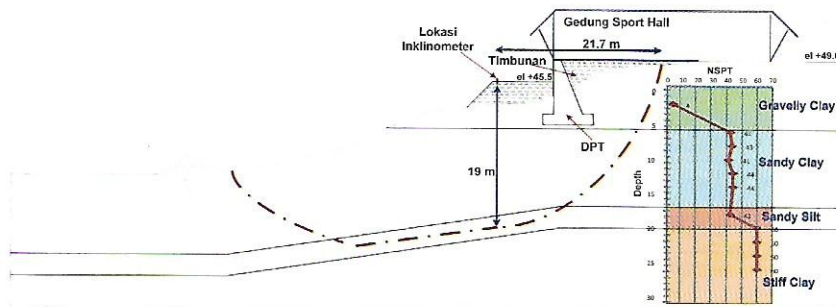
Figure 5b. Simulation of Landslide Conditions (source: GEC Report, 2014)

Following are some references of the conditions that are in the field after repaired are carried out especially in Sport Hall Building of Unika Soegijapranata Semarang which still continues to suffer damage due to land movements that occur in Bendan Dhuwur. There were 8 bored piles as soldier piles had been installed in 30 m depth and 60 cm diameter to increase the soil strength and to retain the soil movement (plaxis modelling). Unfortunately it can't stop the soil movement.

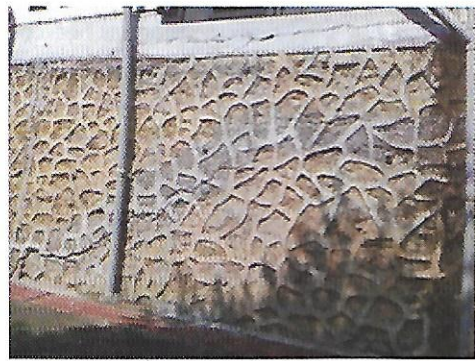
(i) South Direction

Based on soil repairs using Soldier Pile in front of the retaining wall structures of Sport Hall Building, today the cracks at the retaining walls still occur. The condition of the crack can be seen in the following documentation.

Figure 5d. Cracks at The Retaining Wall

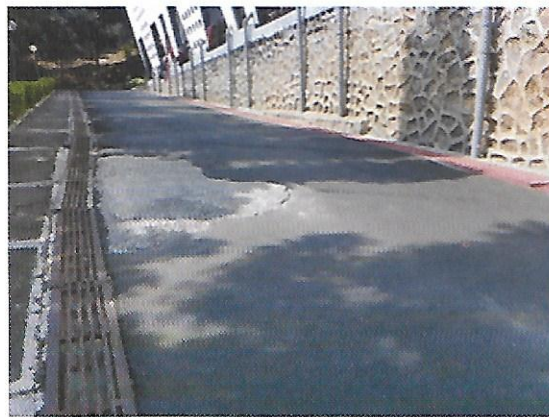
Figure 5e. Cracks at The Path of Sport Hall Building (West Direction)

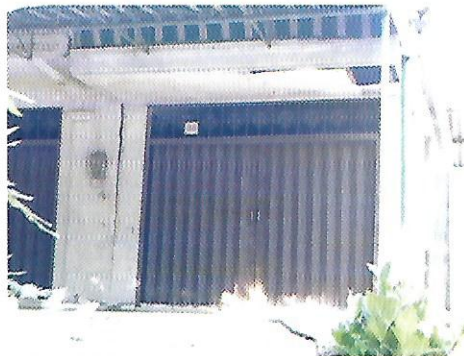
(i) Crack at the Wall of House

Figure 5g. Cracks On The Wall and The Retaining Wall at Pwiyatan Luhur Street

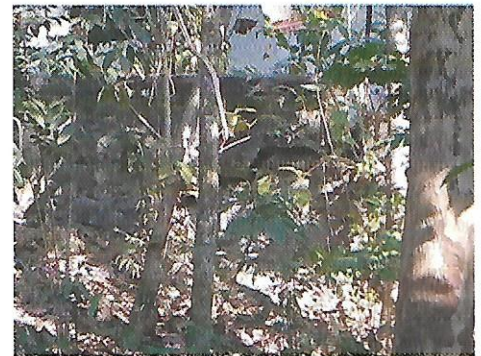
(ii) Crack of the Retaining Wall

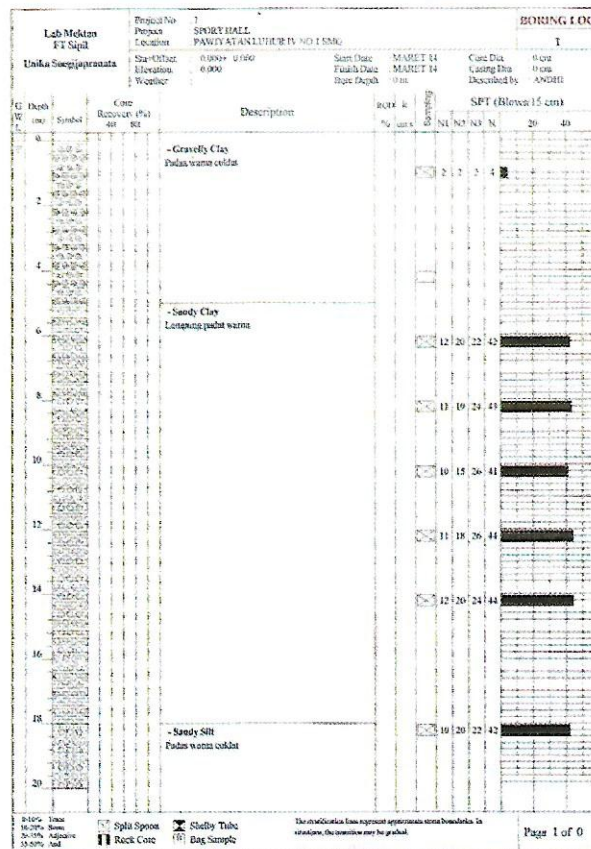
Figure 7. Sport Hall Borlog (Unika Soil Investigation Report, 2014)

depth between 1.50 - 5.00 m is thought to be hollow due to granules eroded by underground water flow during the rainy season.

It can be seen that the soil investigation result from borlog are dominated by sandy clay and sandy silt soil types. The SPT number after the depth of 5.00 is relatively high (> 40 blows). This shows very hard soil consistency. Unfortunately, at drilling below the depth of 1.50 m to 5.00 m, the soil sample is not taken at all (empty / lost). This condition indicates that the soil below the

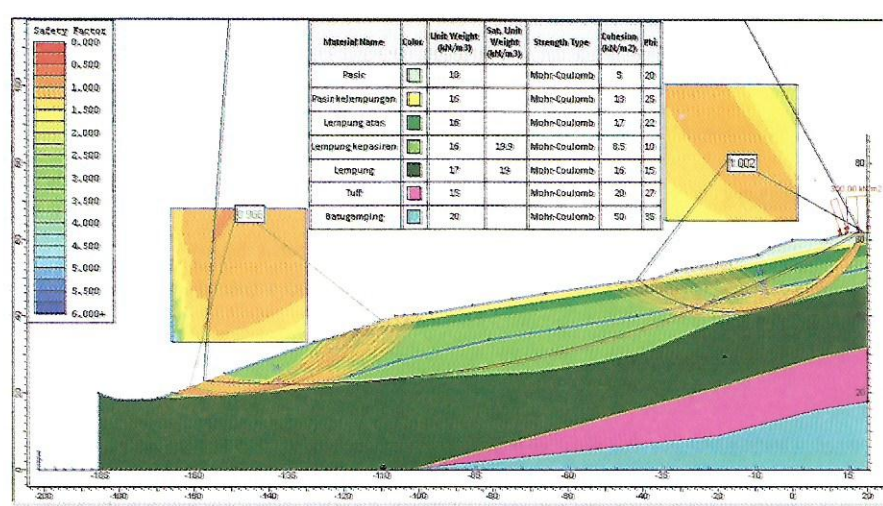
Figure 10a. Slope Stability Without Grouting

It can be seen from the picture, that when there was no soil improvement, the safety factor of the slope was 1.002. Meanwhile, after using grouting to improve the strength of the soil properties, safety factors increased until 1.2.

Due to the limited data available in the field and in the laboratory, it has been analysed by back analysis to obtain the initial parameters. Soil improvement at this location was modelled using grouting for a short term to minimize the soil movement. Figure 10a – Figure 10b shows the results obtained from the analysis.

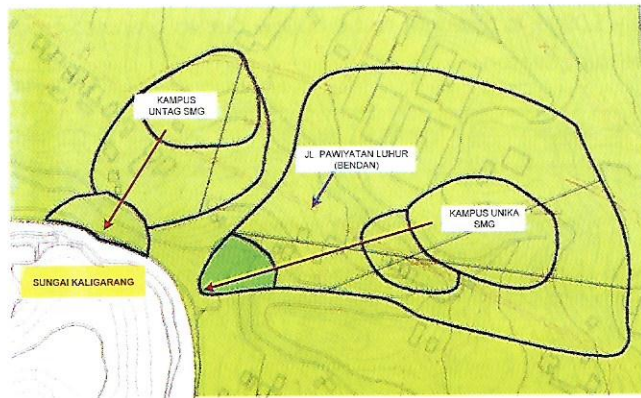
Figure 8. Direction of Soil Movement Maps (Source: 2016 Napak Tilas)

The direction of ground movement is illustrated in the form of a ground movement map as shown in the following figure. The map can be illustrated based on the results of a field survey of the direction of land movement that occurs in the field. Measuring the direction of soil movement was carried out with the help of a geological compass tool to describe the deep-strike of cracks that appeared at the study site.

It can be seen on the map that the direction of soil movement occurs towards the same point, the riverbank of the Kaligarang river, that has been eroded by river current at southwest direction. This condition illustrates that if the Kaligarang riverbank continues to be eroded, the soil material around it will move towards the bank. Carrying soil material is thought to originate from the surrounding soil, including soil materials from Pawiyatan Luhur street. The flow of water from the rain carrying material also leads to the banks of the Kaligarang river.

- cavities form due to eroded soil material
- when heavy traffic passes the road, it can cause a decrease due to the hollow soil layer
- if continuous handling is not carried out on the banks of the Kaligarang river, then the movement of land on Jl. This Pawiyatan Luhur in particular will not stop moving
