# Preliminary Assessment of Building Damage Potential Due to Landslide (Case Study Gua Maria Kerep Ambarawa, Central Java)

<sup>1</sup>Civil Engineering Study Program, Faculty of Engineering, Universitas Katolik Soegijapranata, Semarang, Central Java, Indonesia

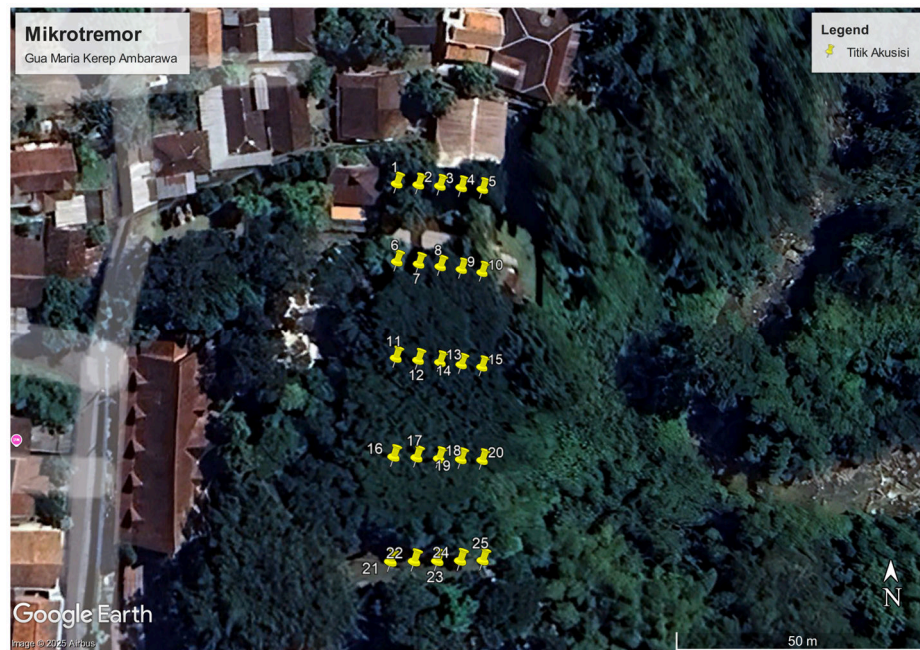
Figure 7. Georadar testing layout

beam strong and causing it to bend in the middle of the span between columns. Behind the concrete block wall, there is a ravine and some landfill, which keeps some parts of the wall straight due to the support from the landfill. Next, geotechnical testing was conducted to determine soil deformation in the area shown in Figure 5c, using georadar. The research location is shown in Figure 7. The coordinates of the Georadar testing location can be shown in Table 1.
