Evaluation of Home Sanitation System in Tidal Areas , A Case Study of Kemijen Village, Semarang, Indonesia

IM. Tri Hesti Mulyani* , Etty Endang Listiati* , B.Tyas Susanti* , Djoko Suwarno**

Soegijapranata Catholic University, Semarang, Indonesia

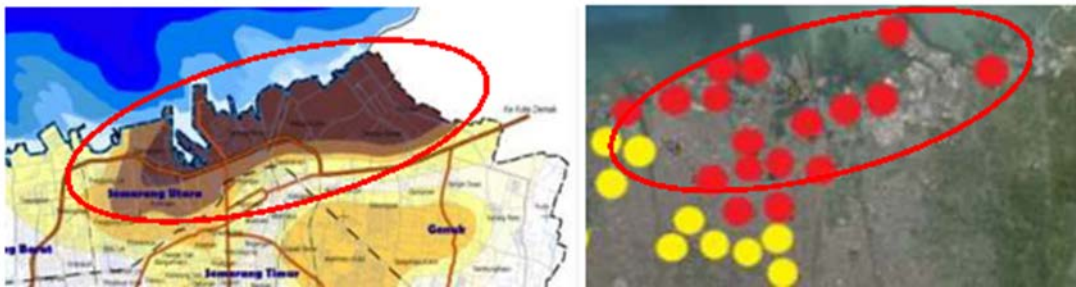
Figure-3: The comparison of the land subsidence maps in North and East Semarang.

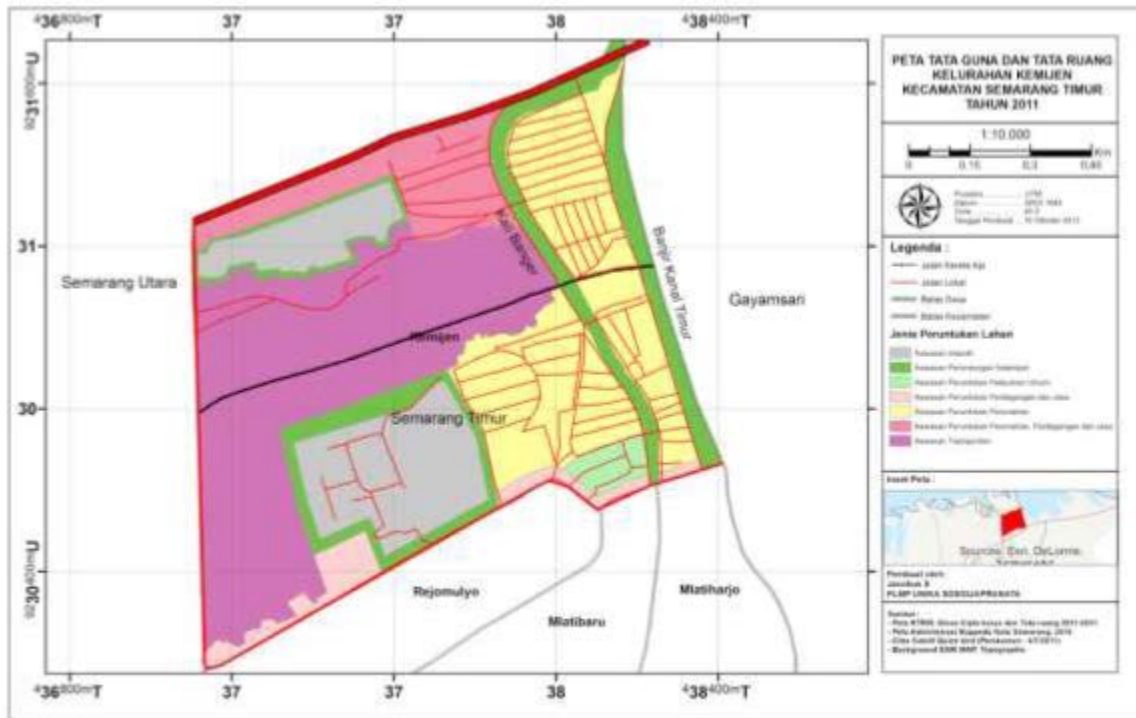
Kemijen Village is one of residential areas routinely struck by tidal flood. The village consists of 11 RWs with the borders that can be seen in the figure below..

Figure-4: The Map of the Use and Spatial Plan of Kemijen Village, the Sub-District of East Semarang in 2011
Source : Jacobus S, PMLP Unika Soegijapranata Semarang, 2011

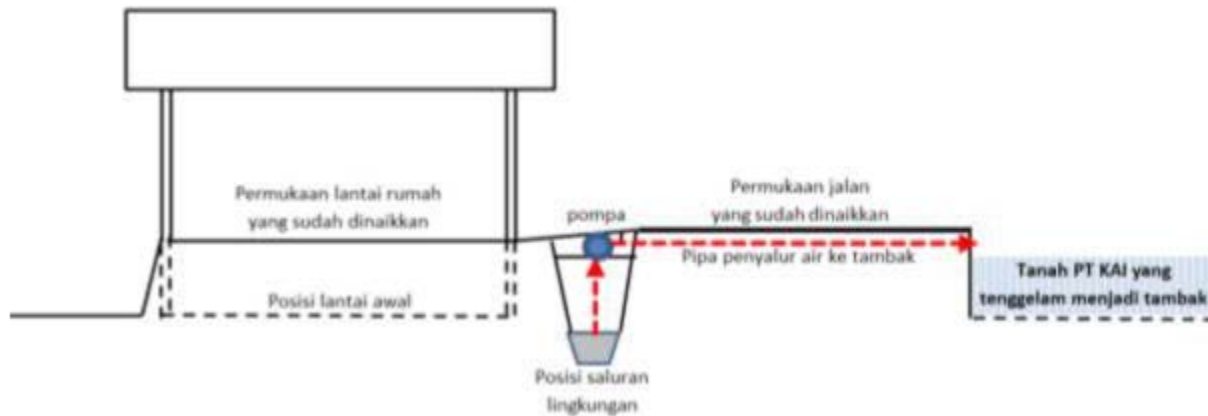
The effort was made because the position of the environmental channel is much lower than and pond waterfront. Without the pump, water cannot flow into the dump.

Figure-7: the scheme of the positions of environmental channel, pump, and retention pool in RW-IV of Kemijen
Source: Mulyani TH, Semarang 2017

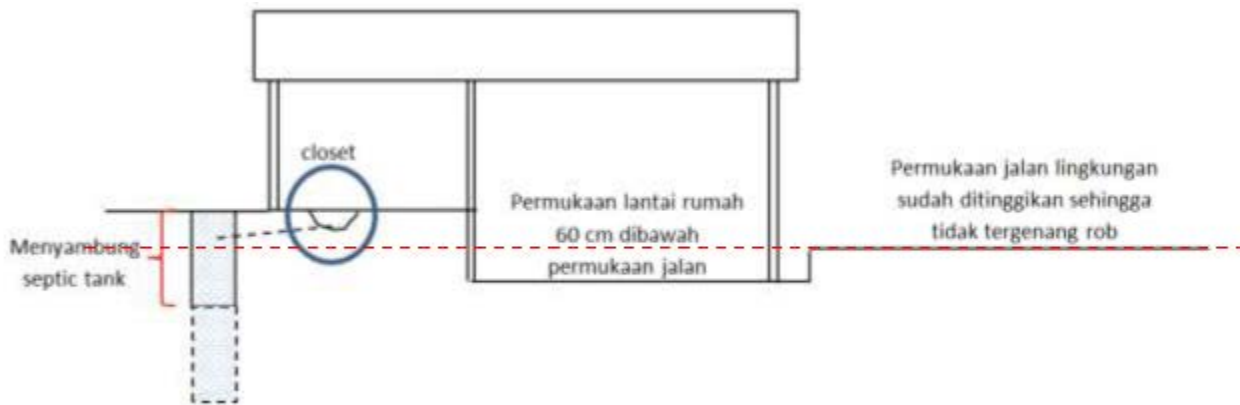
The house belongs to the category of the house that had not been able to overcome flood/ tide because the floor of the house was 60 cm lower than the street level. The sanitation issues are solved by raising the bathroom floor level and connecting the septic tank to about 1.5 m high from the floor surface of the house. Therefore, when the house is flooded, the bathroom can still be used. The solution scheme can be seen in the following figure.

Figure-9: the solution scheme of raising the sanitation of bathroom/ toilet
Source: Mulyani TH, Semarang, 2017

With a wet system, it demands smooth flow of water for flushing. The system can work well when the closet is in a dry position (not inundated) by flood/ tide). The red lines in the Figs. 8-11 and 13-14 show the elevated street surface positions in order not to be inundated by flood/ tide. In the case of the houses number 3, 5, 6, the closet position was under the surface of the street (below the red line). It means that it will be inundated during the flood/ tide, so the closet could not be used because the flushing water could not flow. In the case of the houses number 1,2,4, the position of the closets was raised and the septic tank hole was connected upward. It was intended that in flood/ tide the flushing water can still flow smoothly to the septic tank.

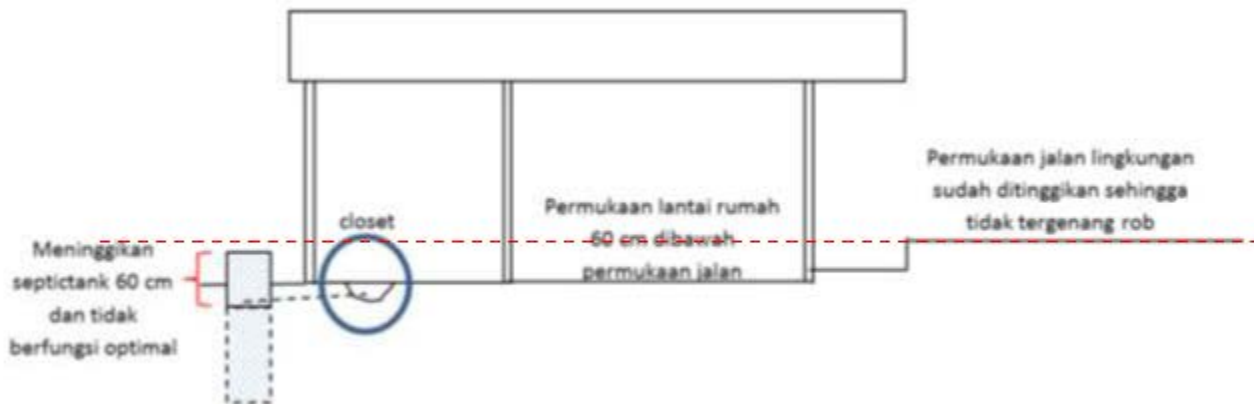
3. Mr. Bambang Susilo's house
The house belongs to the category of house that had not able to adapt to flood/ tide. The height of the floor surface was 60 cm lower than the street level, and there was no change in the height of the bathroom and toilet. Therefore, it can not be used when the house is struck by flood/ tide. The solution made by the resident in the conditions was to evacuate to another place. The scheme of the sanitary condition is as follows:

Figure-10: the solution scheme of raising the septic tank
Source: Mulyani TH, Semarang, 2017

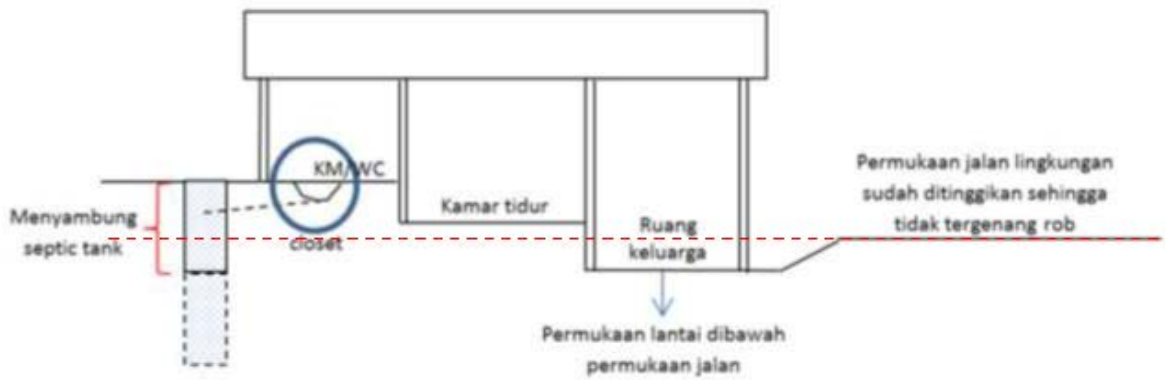
Overall, the condition of this house was very apprehensive because most of the houses had been destroyed. One-third of the building that can still be occupied was optimized by elevating the rear floor for bedroom and bathroom so that when flooded it still can be used. The height of the floor surface of the front house (living room) was under the street level. The sanitation problems were solved by elevating the bathroom at the back to 1.50 m higher than the living room floor. The solution scheme performed on the bathroom part is as follows:

Figure-11: the solution scheme of raising the sanitation of bathroom/ toilet
Source: Mulyani TH, Semarang, 2017

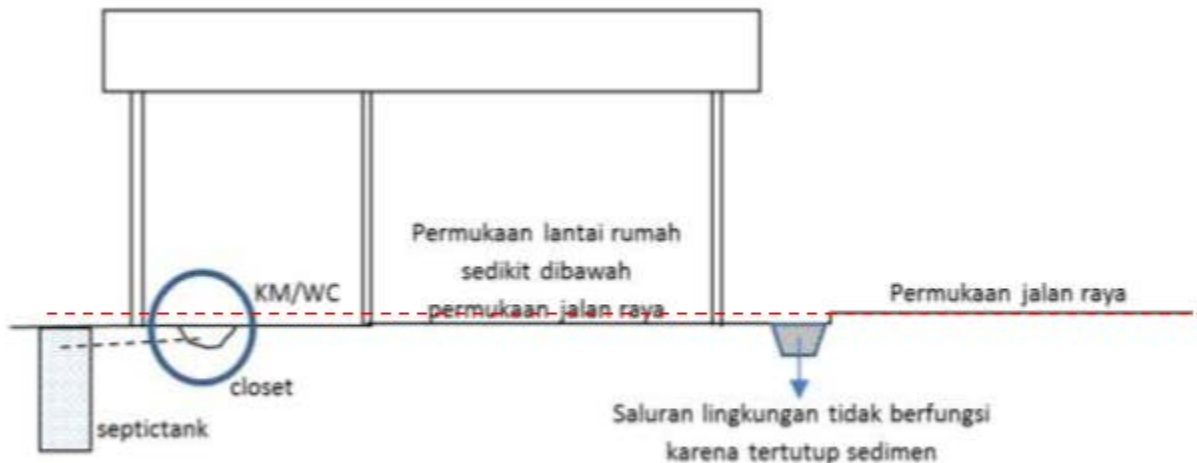
Around the house, there was no sewerage, so the water was inundated in the yard of the house. The floor height of the house was slightly lower than the main street (Komodor Laut Yos Sudarso Street). The sanitation problems in the bathroom and toilet had no solution because the surface of the floor was slightly lower than the main street. Therefore, when flooding, the bathroom could not be used. The scheme of the sanitary conditions can be seen in the following figure.

Figure-14: the scheme of the sanitation position of bathroom ad toilet with no solution effort.
Source: Mulyani TH, Semarang, 2017

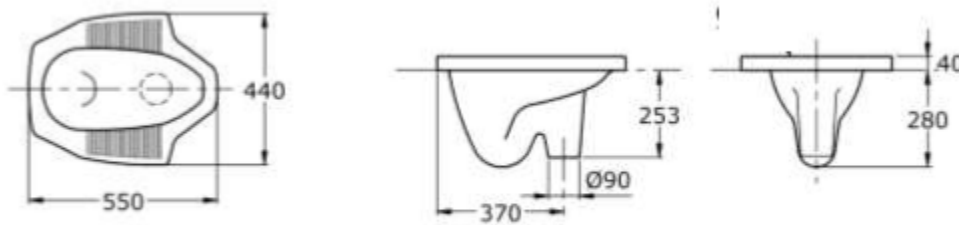
The sanitation system in the toilets in most homes in the study sites used the conventional wet systems using water for drainage (Hans Van Bruggen in Darwati S, 2007). The type of the closet used was squat closet as shown in the following picture.

Figure-15: Squat Closet

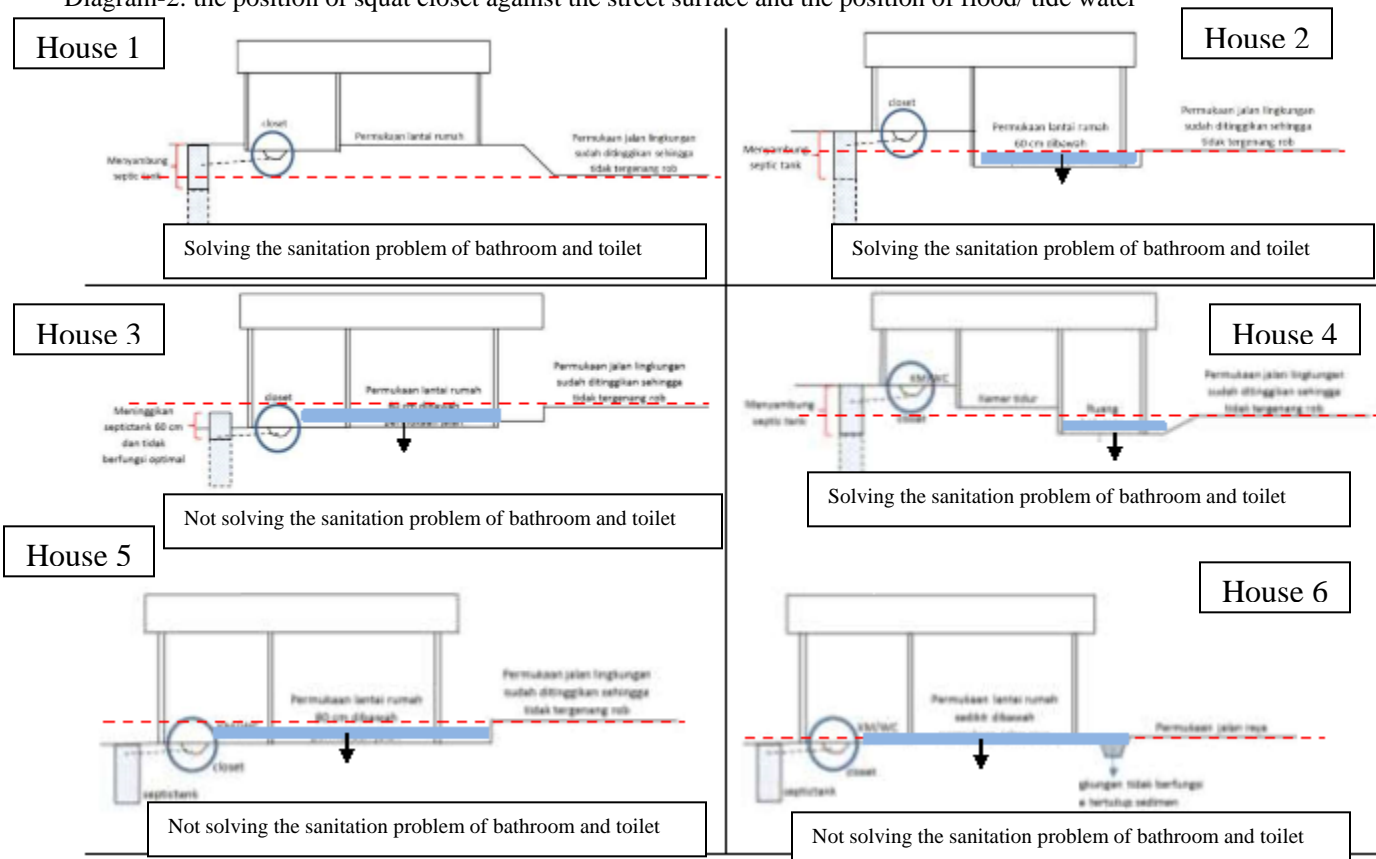
The comparison of squat closet position with street surface and flood/ tide water positions in the six cases of the houses can be seen in the following diagram:

Diagram-2: the position of squat closet against the street surface and the position of flood/ tide water
