CAUSED AND DIRECTION OF SOIL MOVEMENT GOMBEL LAMA – PAWIYATAN LUHUR STREET SEMARANG CENTRAL JAVA

ABSTRACT: Soil movements that often occur in many sloping areas cause damage to the infrastructure around the location. Likewise, the soil movement that occurred in the area of Semarang Pawiyatan Luhur street has caused continuous damage to the main street and building facilities as campuses and houses. Joint research conducted by several Universities in Semarang showed that the main cause of soil movement occurred in the region was caused by infiltration in the top area and erosion at south-west of kaligarang riverbanks. The direction of movement based on the results of the research shows that it leads to the Kaligarang river in Semarang. This is evidenced by the results of mapping the crack direction and the geological search that has been carried out. Some of the geo-electric test results as well as deep drill tests accompanied by SPT data show the depth of soil shift shows up to a depth of 60.00 meters from the existing land surface. Some proposed short-term and long-term countermeasures need to be done to minimize the soil movements that occur are regulation of sewerage, soil impr

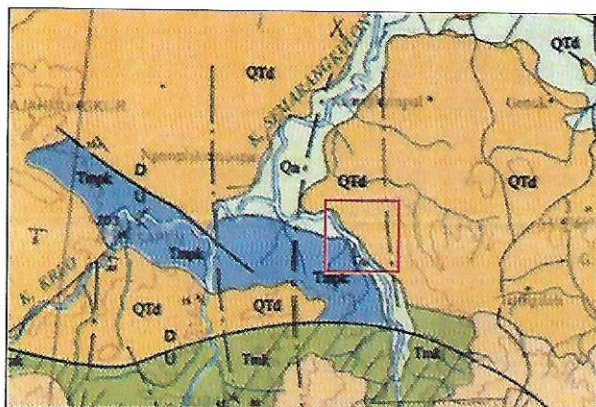
Figure 2. Gombel Lama - Bendan Dhuwur Regional Geological Map (Source: RE. Thaden, et al. 1996)

From the geological map, the red box is the location of the study. This location consisting of rocks and soil as a result of volcanic activity in the form of breccias and brown tuffs that are strong, rock layers or soil are located on the surface. The rotational landslide can be seen from minor scarp

Under the breccia and tuff there is a claystone (green colour at below) which was the result of deep sea deposit activities. In the river cliffs to the north of the research location, we can found some claystone in the form of green clay with soft to firm consistency and flowing landslides characteristics form.

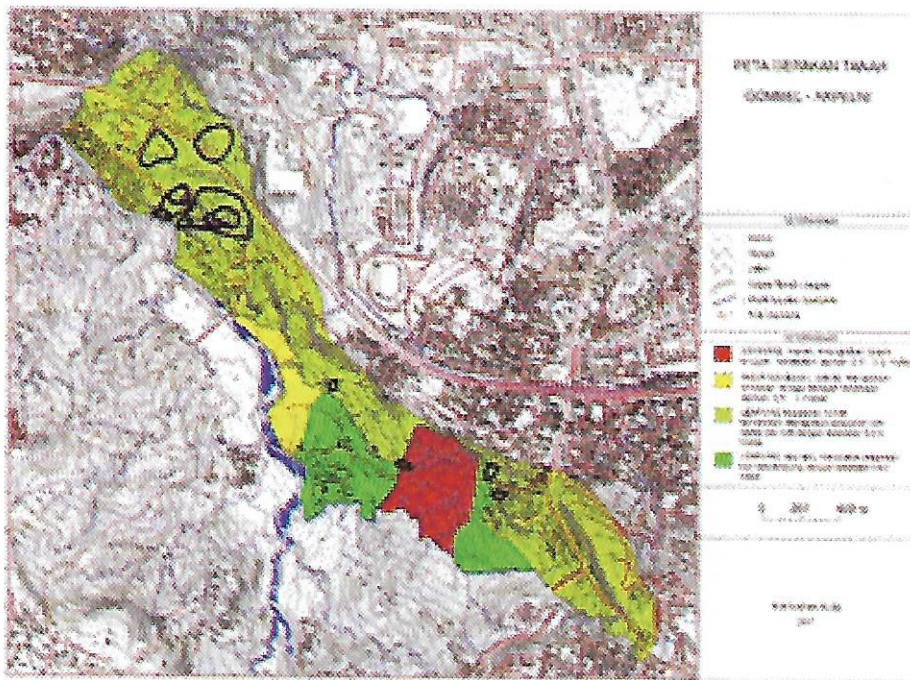
Figure 6. Map of Surface Soil Types (source: 2013)

Based on visual investigation results, the types of soil mapping as land surface maps are drawn from the map above. Generally, it can be described as follows:
