Stage House, A Strategy for Coping with Tidal Flooding in Semarang

Etty E. Listiati*, Tyas Susanti*, IM Tri Hesti Mulyani*, and Widija Suseno**

* Faculty of Architecture and Design, ** Faculty of Engineering
Soegijapranata Catholic University, Semarang

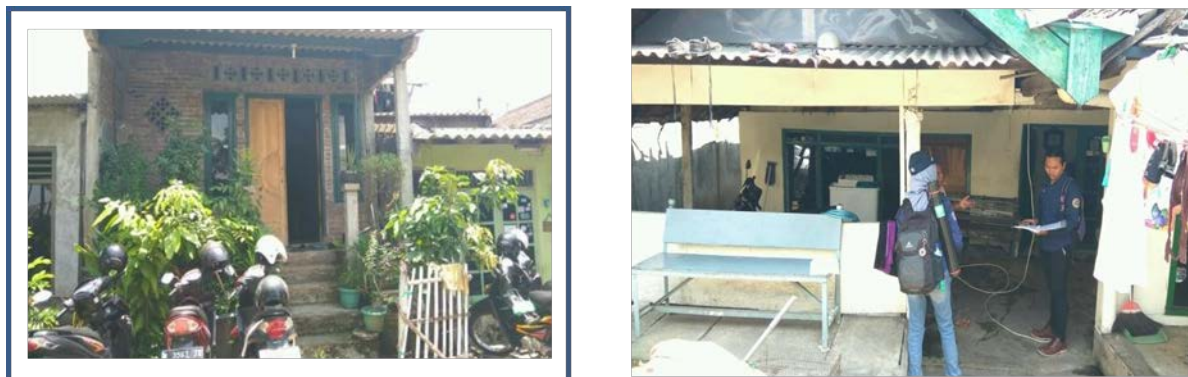
Figure 1: a/left) A house with raised floor level (Mr. Mahdi's house), b/right) a house without the raising of floor level (Mr. Bambang Susilo's house)

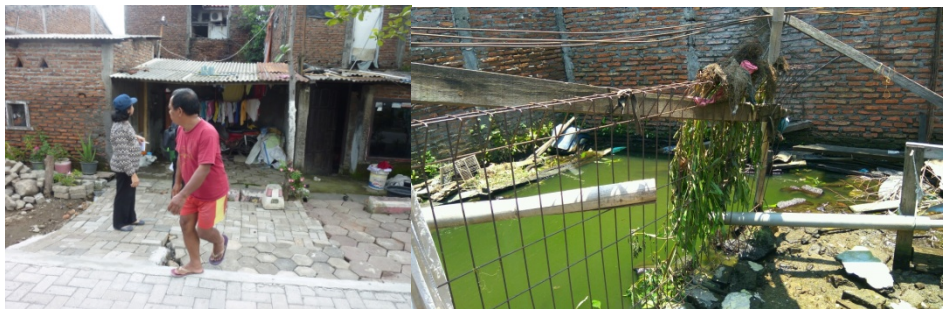
Figure 2 : Mrs. Hanifah's house (a) front view (b) the yard inside the house

Mrs. Hanifah's house was one of the houses which was not raised. The house floor was lower than the street.

Mrs. Hanifah's house (the old/ original building) was always exposed to tidal floods since the floor of the house building was still lower than the street level. In addition, the house was located near a pond, so it affected the groundwater level. The condition made the research team try to make Mrs. Hanifah's house in such a way so that they had a space avoided from puddles. For this kind of environment, the appropriate type of house is a stage house. Stage house does not create the problem of eco system because there is no land filled [2]

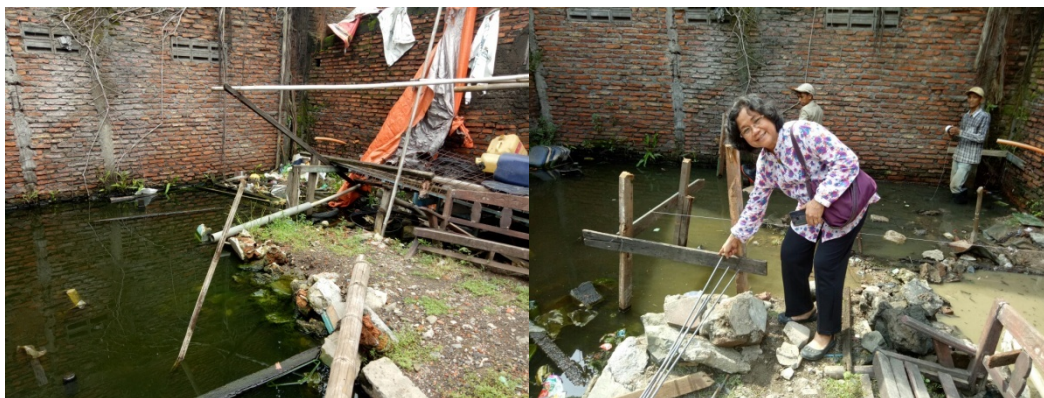
Figure 3 : The location of the stage house to be built in the yard inside Mrs. Hanifah's house.

With the stage house, it is expected that the residents can still move as usual because their feet were not wet because of the water. The stage house in this study was built to the home yard of Mrs. Hanifah (Mr. Heri) which was still often exposed to tide (the puddle of tide was found) at RW IV (Rukun Warga IV). The home yard of Mrs. Hanifa still had the vacant land with 6,9 meters x 7,5 meters, which was always inundated with water. The stage house built was positioned adjacent/ coinciding with the old/ original house building so that it can be interconnected later.

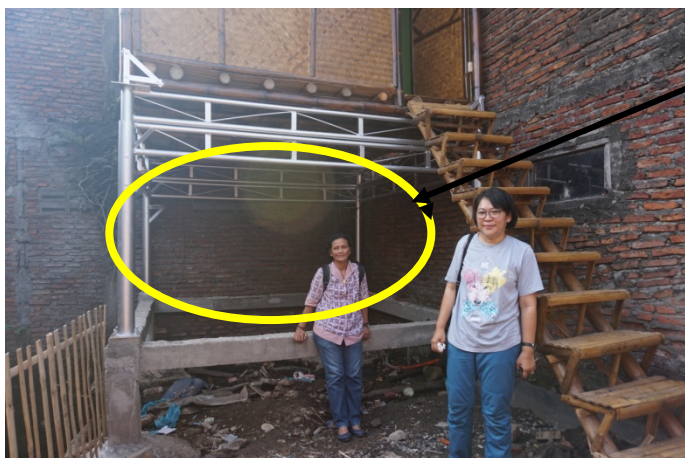
The presence of the stage house of 1.5 meters higher from the ground level was useful as the empty space under the floor could be used for other activities, such as sitting around while chatting and relaxing. It can be done when there is no tidal flood.

Figure 4: An empty space under the stage house

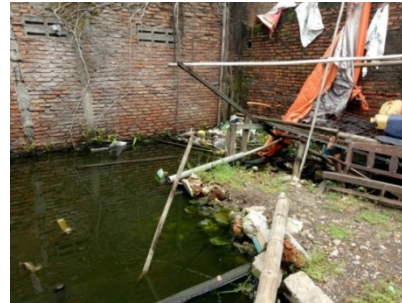
Figure 5: The sketch of Mrs. Hanifah's house and the position of the stage house that would be built over the inundation of tidal water

The stage house made with the dimension of 3 x 3 square meters is a roofed room and given a covering wall and doors. The space can be used for the regular activities (rest, sleep, sitting) of the occupants (more than one). The size of 3x3 square meters was taken based on the module of the average house size in RW IV of Kemijen Village (9 x 13 square meters).

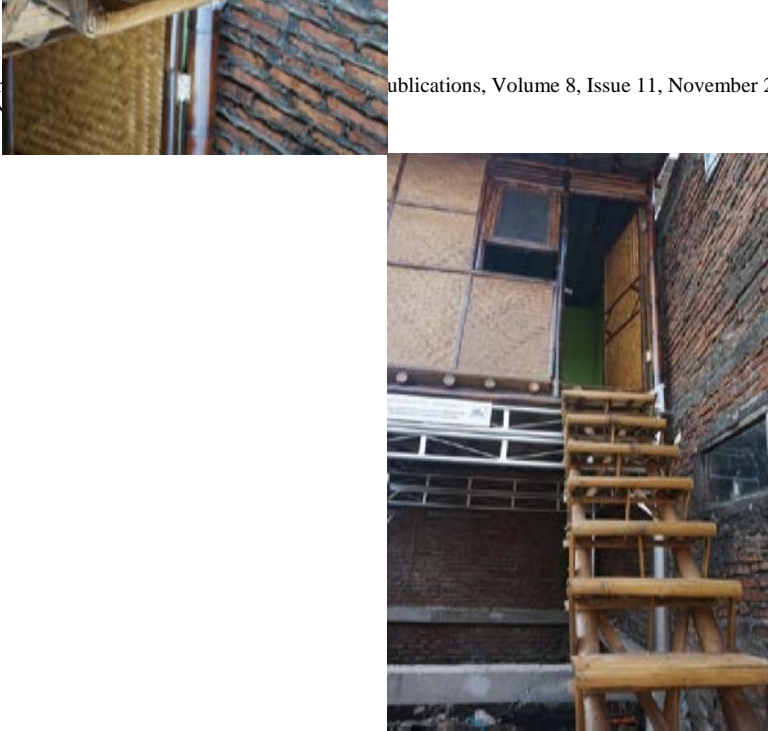
To reach the house floor of 1.5 meters, the stairs of bamboo were made with the width of 90 centimeters the height of 20 centimeters.

Figure 6 : The stairs to the stage house made of bamboo

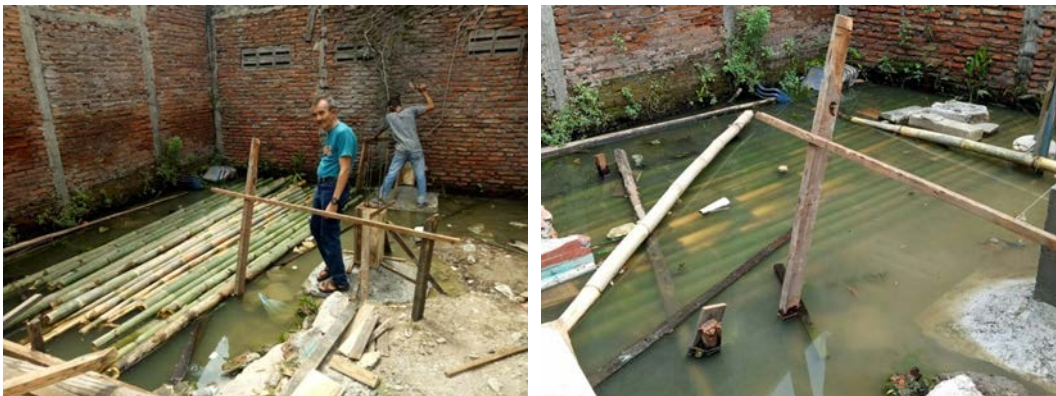
Figure 7: The soaking of bamboos in tidal pond

The stage house was made of bamboo. Bamboo was selected as the main building material because it is light and easy to find. As a building material, bamboo can last long when preserved in advance. It was also applied on the stage houses made/ built. The bamboo used as a construction material was *petung* bamboo. For the pillar, the bamboo used had the diameter of 15 centimeters. The bamboos were preserved before they were used for the buildings. The preservation was done by soaking. Given that the environment, including Mrs. Hanafi's yard, had a puddle of tidal water, the bamboo soaking was done in the location as well so that the implementation was relatively easy and close for the transport.

The implementation of the construction of the stage houses is expected to be carried out by mutual cooperation by the residents due to the togetherness (guyub) of Kemijen residents especially in RW IV. The preservation of bamboos could be done in Kemijen environment which was still inundated (swamp area), and the bamboo work required no special skills. Because the tidal water was not always inundated, in low tide (wet-dry), the bottom of the stage house used galvanized iron or concrete material that was relatively resistant to wet and dry conditions alternately.

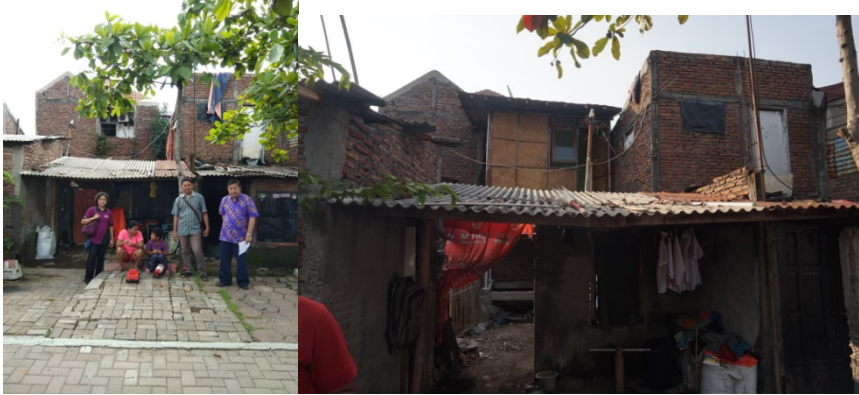
In the figure below (figure 8), it shows the connection between the original house and the stage house.

Figure 8:
Front View of Mrs. Hanifah's House Before Stage the House Construction.
Front View of the Stage House from the Street (the front side of Mrs. Hanifah's house).

The stage houses were built adjacent to the old/ original houses, allowing the "interconnection between buildings/ spaces". In addition, in the other parts, there were still water puddles used for bamboo soaking.

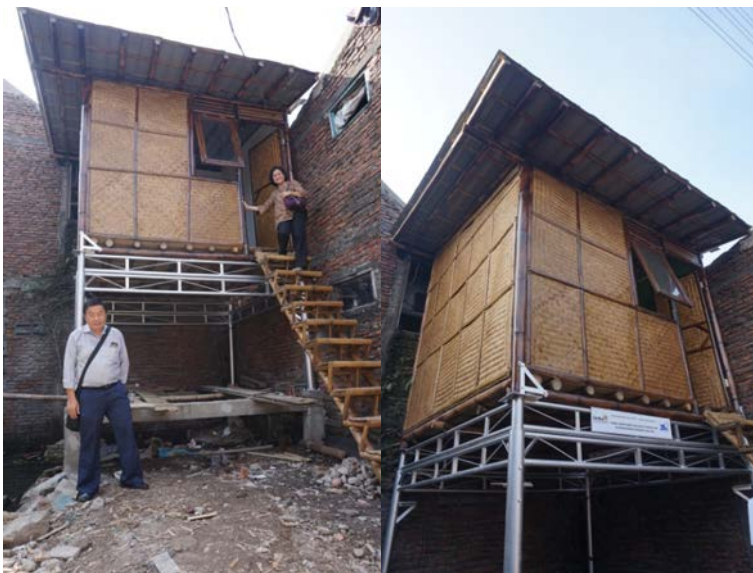
For the appearance/ facade of the whole stage house building made of bamboo, it was finished using brown varnish, which did not change the natural color of the bamboo. This bamboo stage house can be seen from the front side of Mrs. Hanifah's house, so it is quite a contrast with the surrounding houses. Natural impression appears in an area that is friendly to nature in the area dominant with water.

Figure 9: Outside view of Mrs' Hanifah's stage house looks natural because the building materials are dominant with bamboo.

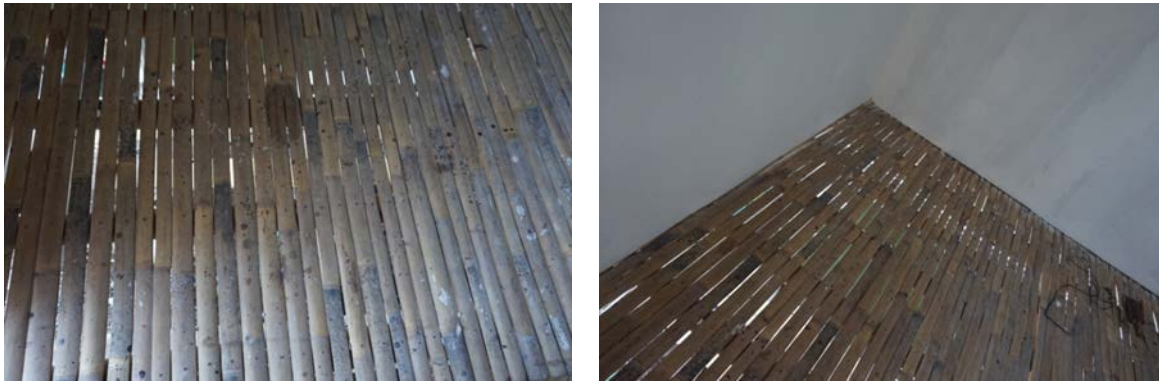
Figure 10 : the stage house's floor;preserved bamboo blades were used

The floor of the house was also made of bamboo blades that could be made by the residents, and then the blades were woven.

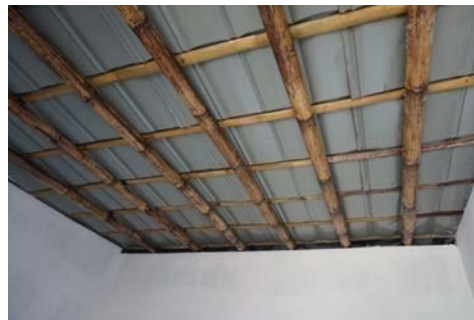
For the building blanket, woven bamboo was used on the outside part, so the woven bamboo can be seen on the building facade. For the inner wall, calciboard was used as covering wall. It was used to avoid any disturbance of rats and other insects (when bamboo woven is still used) since the plaited bamboo is vulnerable to be gnawed by rats. However, with a closed calciboard, the wall pores of woven bamboo for circulation are blocked. Therefore, it is necessary to make windows for air circulation and lighting as well as outlook. In the stage building, windows were made on the front side, next to the door. It is adequate for lighting, but it is not adequate for circulation. Therefore, ventilation holes are still required. For this stage house model, the back side is neighbor's wall, so windows cannot be made. The possible solution is cross-ventilation is made on the left-right side wall as the side is still the land of Mrs. Hanifah's house.

Figure 11 : a)Window for lighting b) Wall cover of calciboard; rafter and batten of preserved bamboo

For the rafter, the bamboo with the diameter of 8 centimeters was used, and for the batten, bamboo blades were used and made by the people in a mutual cooperation.

The presence of inner walls made of calciboard is expected to be painted with a color that suits the taste of the occupants,so it is more comfortable to live in. The shape of the roof is lasenar with the roof angle of 16 degrees. The shape was chosen in order that the implementation and construction of the stage house is quite easy and efficient. The houses has no ceiling so that the cost of building and construction is lower. However, in the absence of ceiling,it makes the inner space rather hot during the day because there is no air space between the roof and the room. For roofing materials (metal roof),it is made of metal and asphalt that causes solar thermal radiation propagate into the house/ space. The roof materials were chosen because it is relatively light and reasonably priced.
